1426-1446 East Baltimore Street (Commercial Buildings)
1426-1428 East Baltimore Street
Baltimore (Independent City)
Maryland

HABS No. MD-904-A

WRITTEN HISTORICAL AND DESCRIPTIVE DATA

ARCHITECTURAL DATA FORM

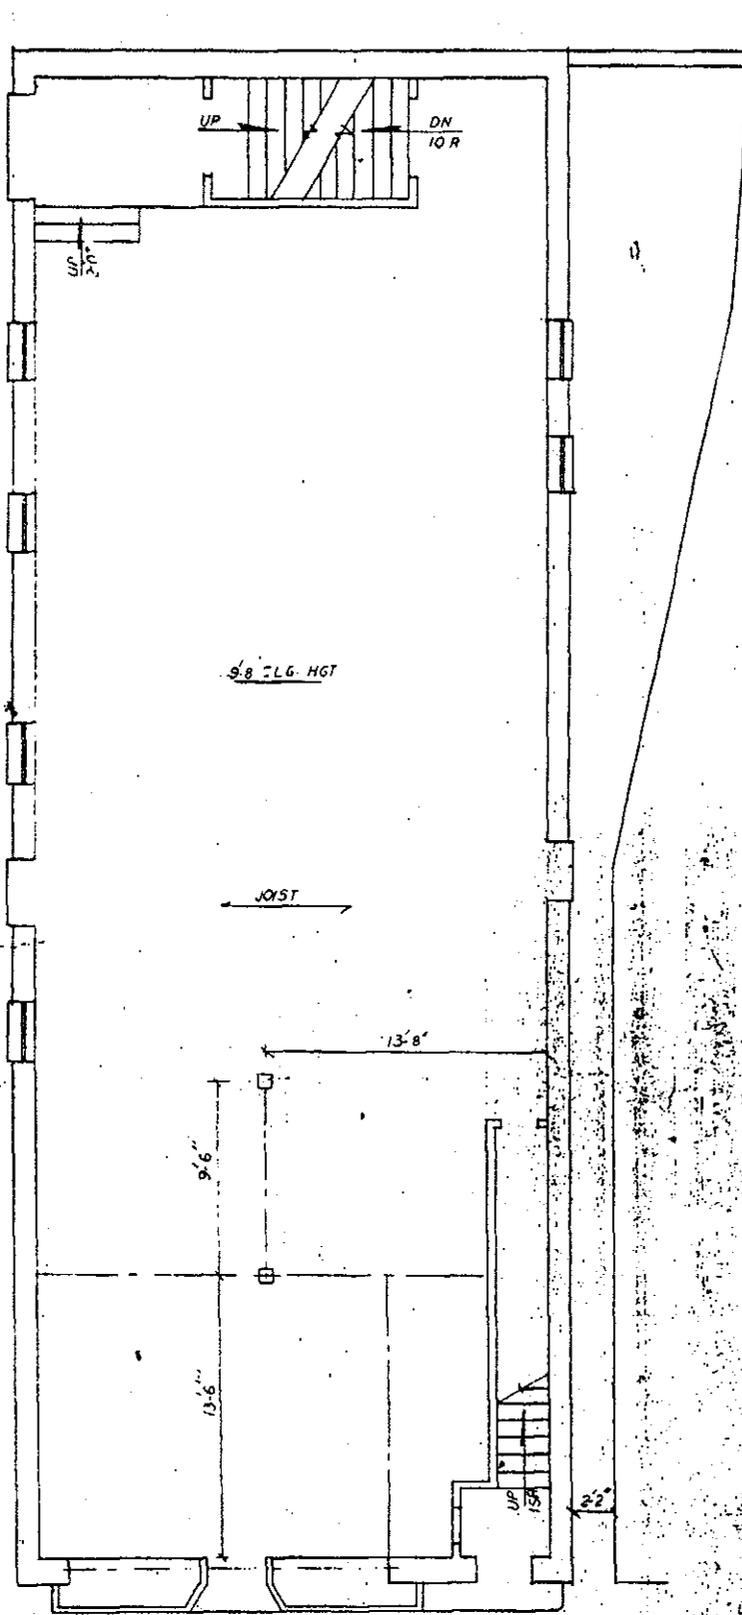
FIRST FLOOR

SHAPE AND DIMENSIONS OF STRUCTURE (SKETCHED FLOOR PLANS ON SEPARATE PAGES ARE ACCEPTABLE) Overall 27' x 74' Rear 27' x 50' (see sketch plan)			
EXTERIOR FEATURES OF NOTE Formstone front, metal cornice, segmental-arched window openings, one/one double-hung windows.			
INTERIOR FEATURES OF NOTE (DESCRIBE FLOOR PLANS, IF NOT SKETCHED) Open plan on 1st and 2nd floors. Many built-in cabinets and display are evidence of the buildings commercial use. Metal ceiling first floor front. " Bullseye " window trim.			
MAJOR ALTERATIONS AND ADDITIONS WITH DATES C. 1911 - Lot combined w/ 1428 E. Baltimore St. and Formstone front applied. Assorted alterations of store front.			
PRESENT CONDITION AND USE This building is in fair condition. Currently vacant the house is suffering from dis-use ie: buckled floor, peeling paint, water damage, etc. and minor fire damage.			
OTHER INFORMATION AS APPROPRIATE For photographs of street, see HABS No. MD-904. Building is intended for renovation to cooperative apartments for artists.
